# Hurricane Ike Meteorological Assessment and Damage Survey September 2008

**WeatherPredict**  
CONSULTING INC.

## Executive Summary

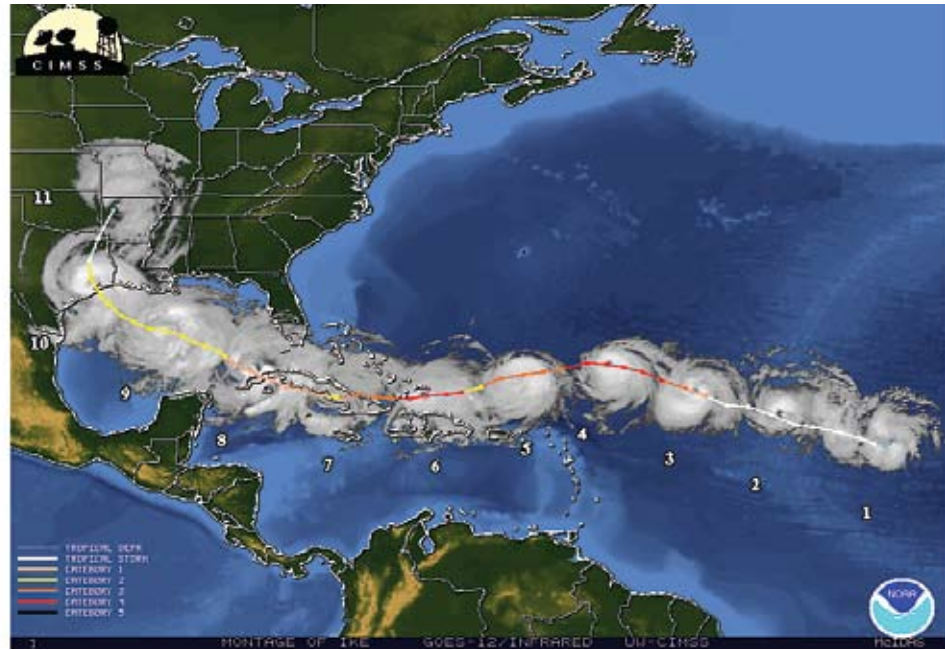
Figure 1: The track of Hurricane Ike.

The eye moved across eastern Galveston Island and straight up Galveston Bay to the eastern side of Harris County and the Houston metro area.

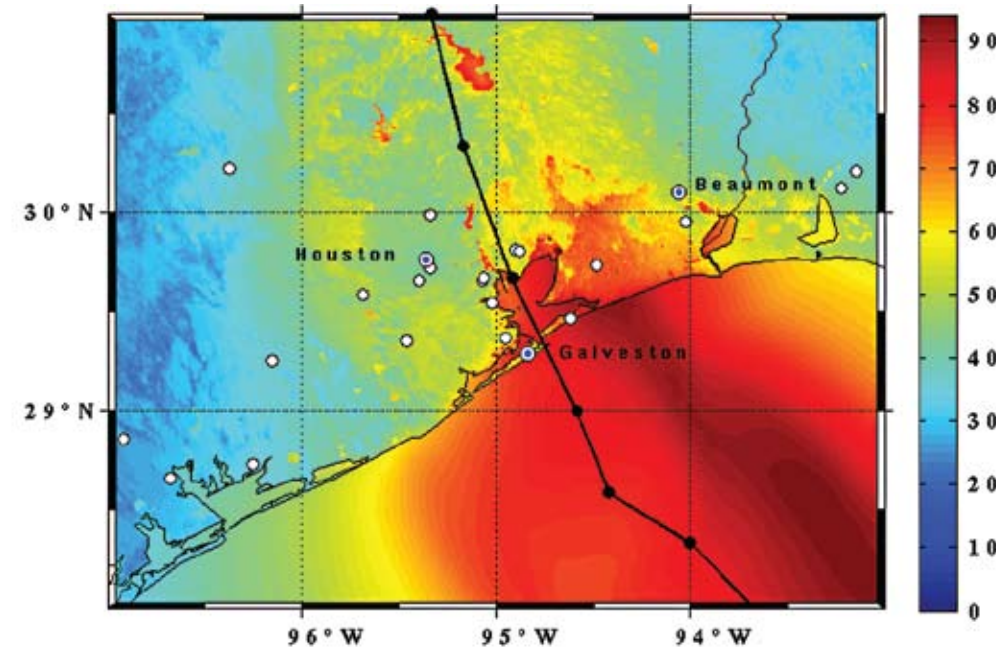
Figure 2: Wind footprint for Hurricane Ike (in knots). Observational stations are indicated with white circles.

The WeatherPredict hurricane footprint model generates a map of the maximum winds experienced at each spatial location in the impact area of the storm.

The WeatherPredict hurricane footprint model generates a map of the maximum winds experienced at each spatial location in the impact area of the storm. The footprint model is driven by a collection of input data that describe various features of the event: position fixes, maximum winds, radius to maximum winds, degree of asymmetry, and overall storm breadth. These parameters are derived from the advisories issued by the National Hurricane Center (NHC). The values issued in real time, however, are based on limited data and are subject to uncertainties and subsequent revisions.

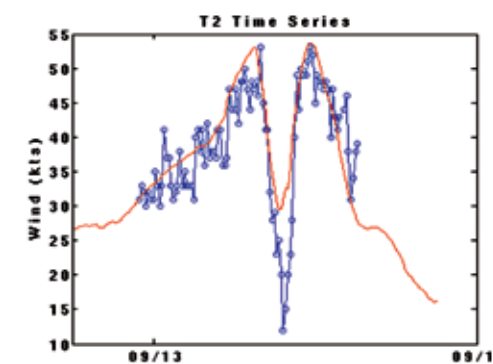
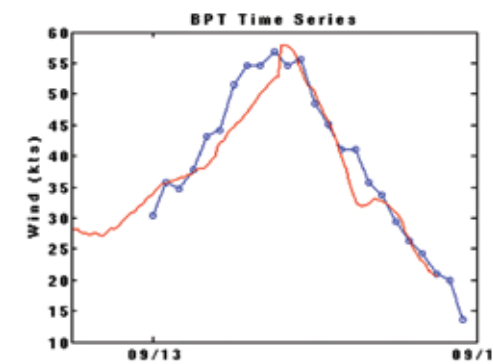
Figure 3: Wind time series comparisons at specific stations. Model results are in red, observed values in blue.

parameters and the results compared to available observational data. For Ike, these observations were comprised of readings from National Weather Service stations, mobile towers from the Florida Coastal Monitoring Program, and, for the first time, WindX™<sup>1</sup> installations. Variations in surrounding terrain, anemometer heights and wind averaging times at the observational sites were taken into account. Figure 2 shows the footprint for Ike, along with the locations of the 20 different wind observing stations that were employed to validate the footprint. Figure 3 shows some examples of time series comparisons.

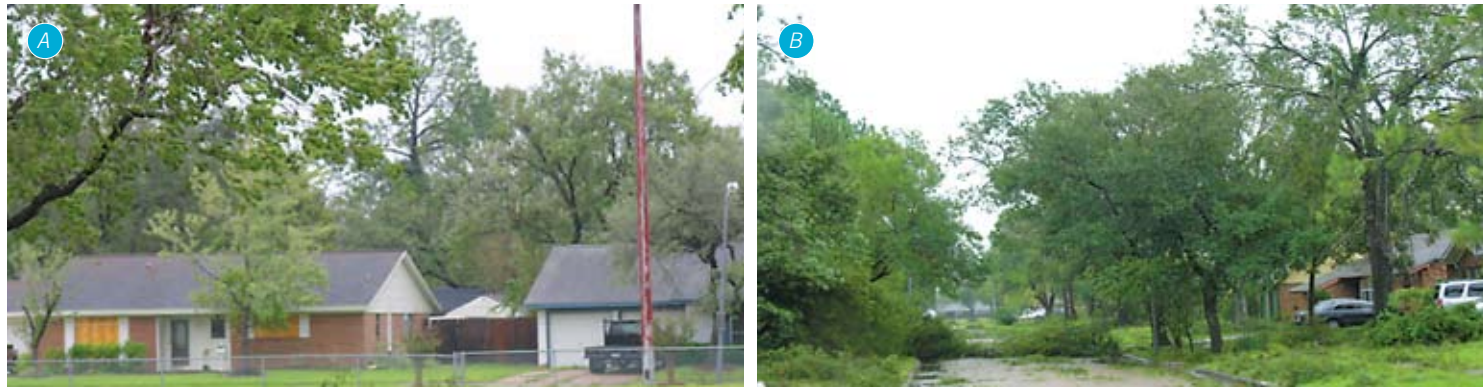
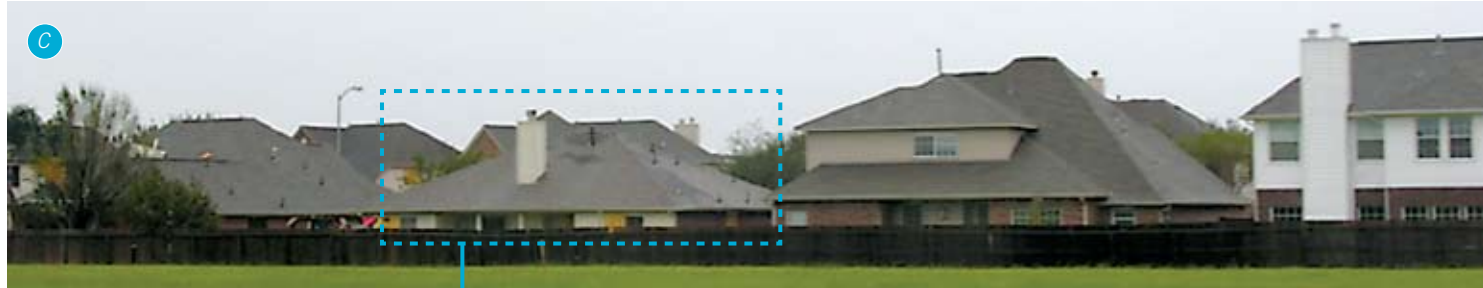
Our Building Team observed Ike to be a widespread event with significant storm surge and flooding affecting many coastal areas from Louisiana through Texas. Direct wind damage, however, was not as severe as originally anticipated, and was mostly observed as sporadic wall cladding and roof cover damage. Residential communities with large and mature tree canopies experienced reduced roof cover damage, as the tree canopies provided shelter from potentially damaging wind gusts. Figure 4A is a photograph of the community of

La Port, where roof cover damage was minimal. In contrast, newly developed communities with less tree protection had more roof damage (see Figure 4B).

In addition to providing a sheltering canopy that reduced the winds, the trees in these areas have deep root systems that resisted toppling onto roofs at the wind speeds present during Ike. This is in contrast to the experience in Hurricane Fran (1996) in Raleigh N.C., where many communities also had mature tree canopies, but the shallow rooted pine trees characteristic of the area toppled onto rooftops, causing high frequency and high severity structural damage. We note that even for those canopies having mature and deep rooted systems, a critical wind speed exists where the canopy will eventually topple. For those geographic regions having lower design wind speed regimes, deep rooted mature tree canopies may reduce expected loss.

Figure 4 - A & B: Communities with mature tree canopies were observed to have less roof cover damage. Note the severe roof damage to the home visible on the far right of figure B.

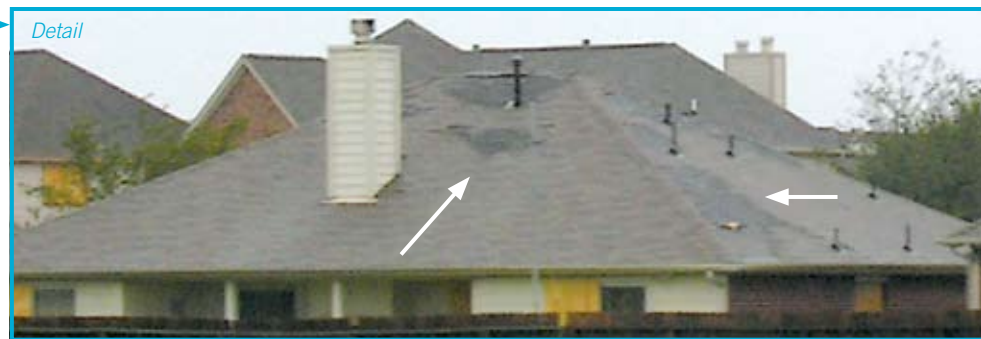
A unique feature noted for the newer Texas (and Louisiana) residential construction was the stylistic change from lower sloped roofs to much steeper roofs (see Figures 4C and 5). The damage patterns associated with the newer steep roofs were observed to occur predominantly in the roof field, which

Figure 4 - C: Newer construction favoring steeper roof slopes.

Figure 5: Steeper roofs display different damage patterns than traditional lower sloped roofs.

is distinctly different from typical roof-edge-focused damage patterns observed with lower pitched roofs.

These observed differences in damage patterns of the two roof slopes indicate that the wind load patterns differ, and suggest that perhaps shingles on higher sloped roofs may not seal as well as those on lower sloped roofs.

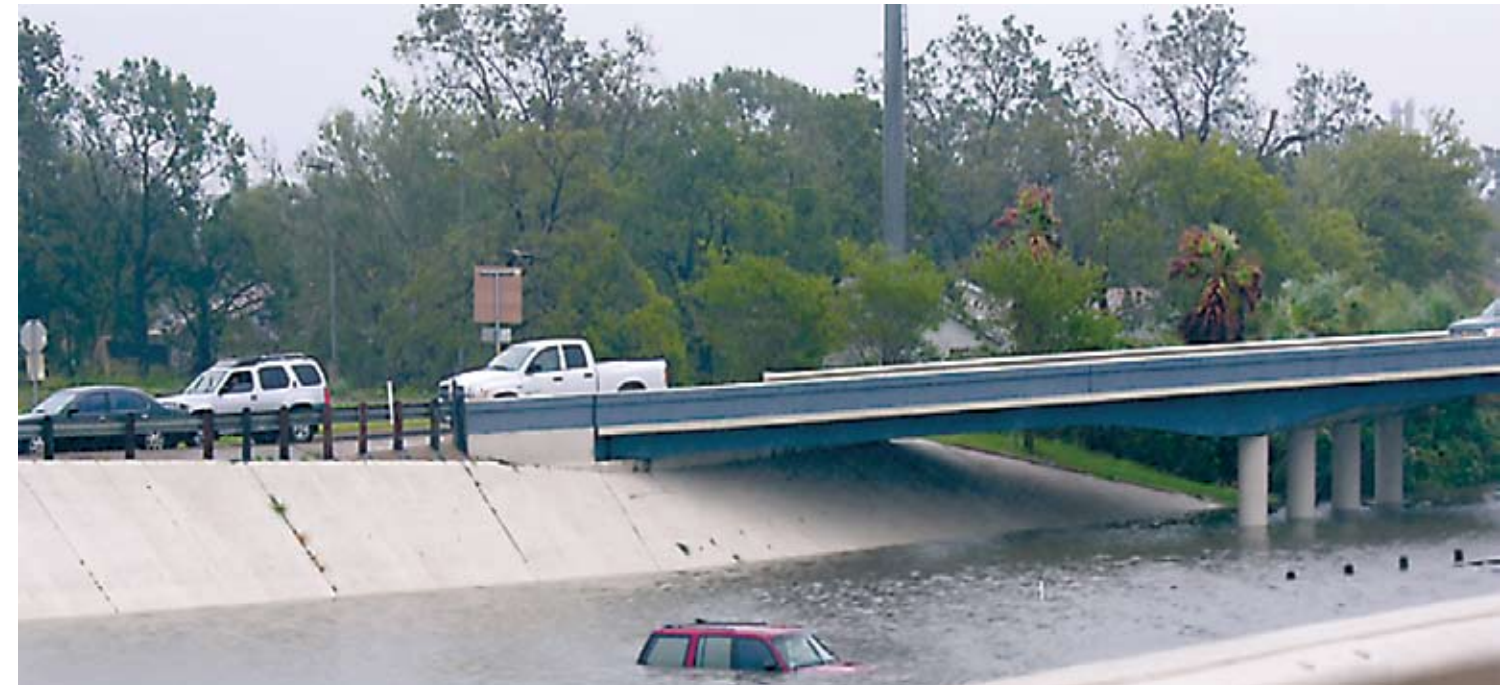
Beyond roof cover damage, damage to the tree canopy (e.g., leaves being torn from branches, tree toppling) is an excellent indicator of likely wind speeds experienced by a community. In the photo of Houston in Figure 6, we see the tree canopy is in very good shape, suggesting lower wind speeds, but that flooding initiated from inland precipitation was significant.

Figure 6: Houston experienced moderate wind speeds, as indicated by a lack of impact on the tree canopy, but inland precipitation from Ike caused significant flood-related problems.

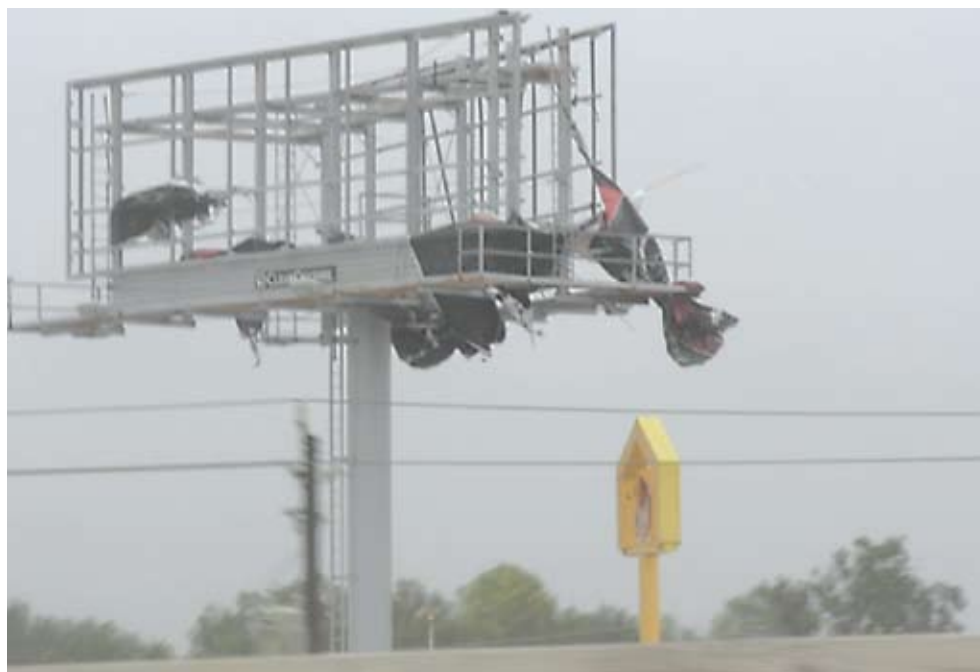
Commercial damage to the Metropolitan Houston area was observed to be minimal overall with sporadic cladding and roof edge damage. Sign damage was observed as the predominant source of flying debris, while gas station roof canopies also suffered damage (see Figure 7).

Figure 7: Commercial sign damage was heavy and was a significant source of debris in the Houston area.

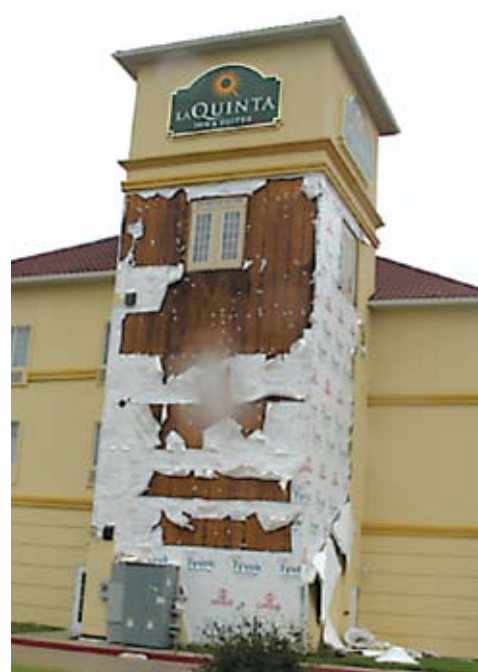
Our team also observed cladding failures associated with Exterior Insulation and Finish Systems (EIFS) construction. Damage to these systems occurs at relatively low wind speeds and tends to show up as dramatic peeling failures (see Figure 8). Compared to other cladding systems, EIFS are among the most vulnerable to failure in wind events. The EIFS failures noted in Ike were also observed following Hurricane Charley (2004)<sup>2</sup> as it went over the Orlando Metropolitan region as a tropical storm.

Figure 8: Cladding that employs Exterior Insulation and Finish Systems (EIFS) were particularly vulnerable to failure.

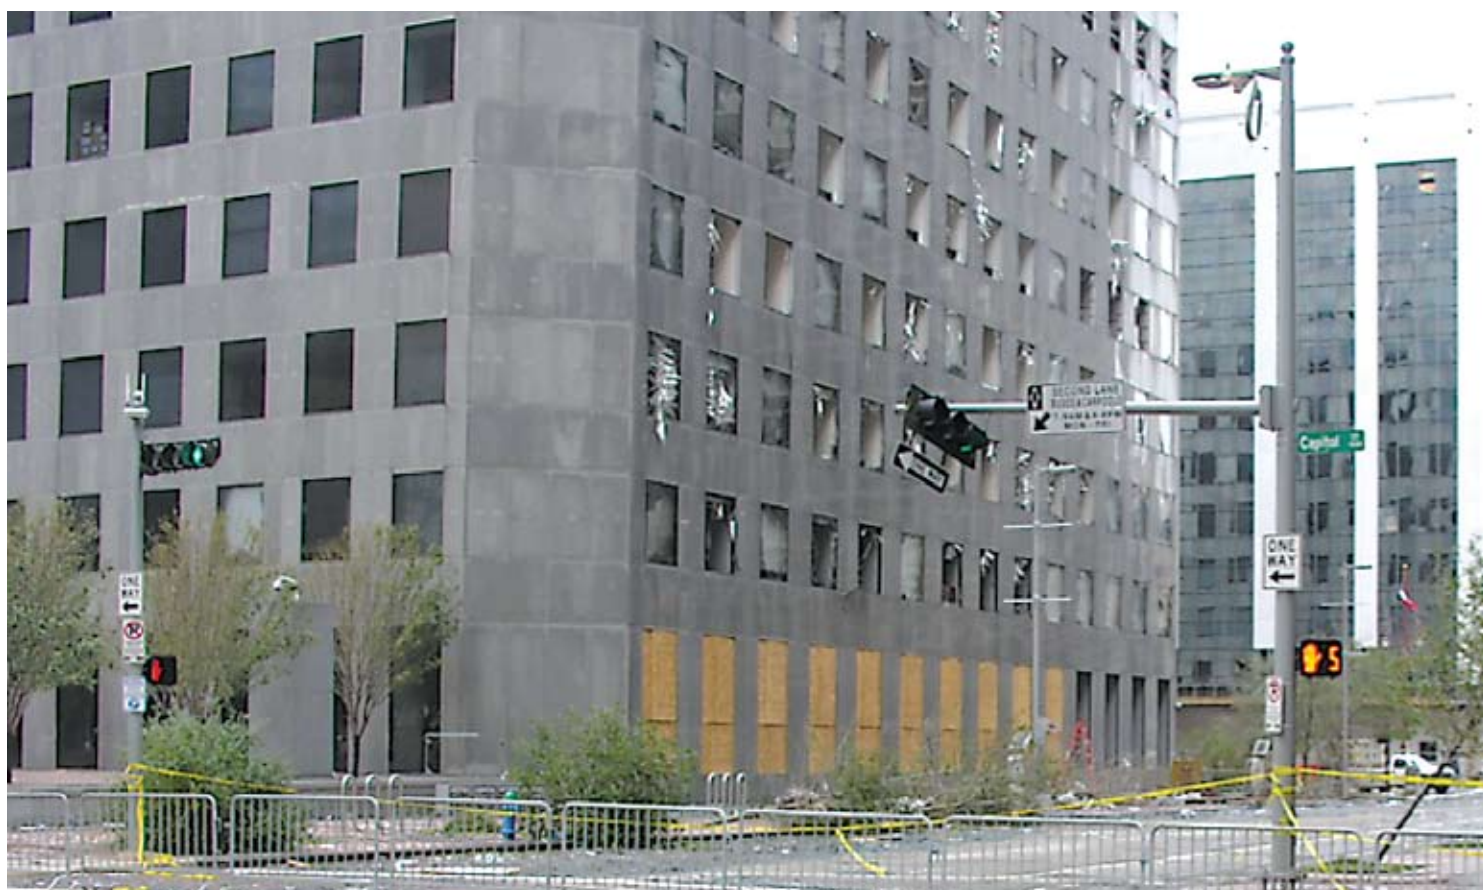
Damage to the high rise building stock was limited mostly to sporadic window glazing damage. The WPC team observed several high-rise structures with dramatic window glazing failures in the downtown area (see Figure 9). The root cause in glazing failures of this type is typically wind-born gravel and other debris from nearby rooftops, but we have not found unambiguous evidence in the debris field surrounding these damaged buildings to suggest this failure mode. An alternative hypothesis blames wind-generated suction forces that cause a few windows to fail by falling outwards, thereby creating a wind-born debris field that leads to a massive cascading failure of other windows on both the original and nearby buildings. Overall, commercial construction fared well in this event, owing mainly to the moderate wind speeds experienced.

Figure 9: Commercial window cladding damage was limited to a few sporadic cases.

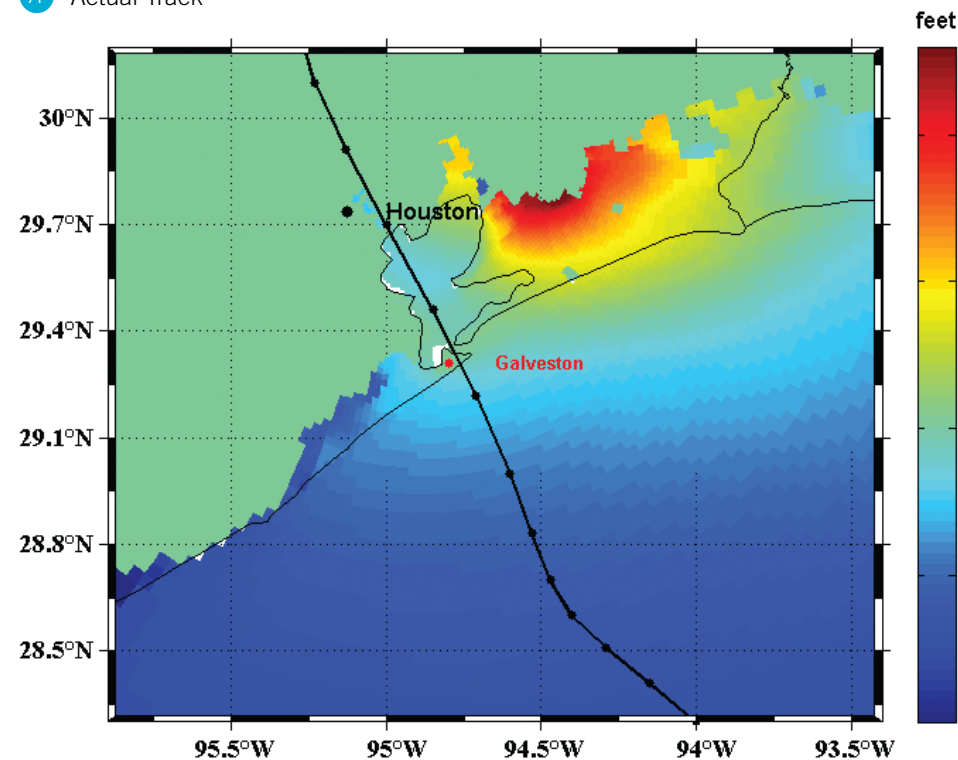
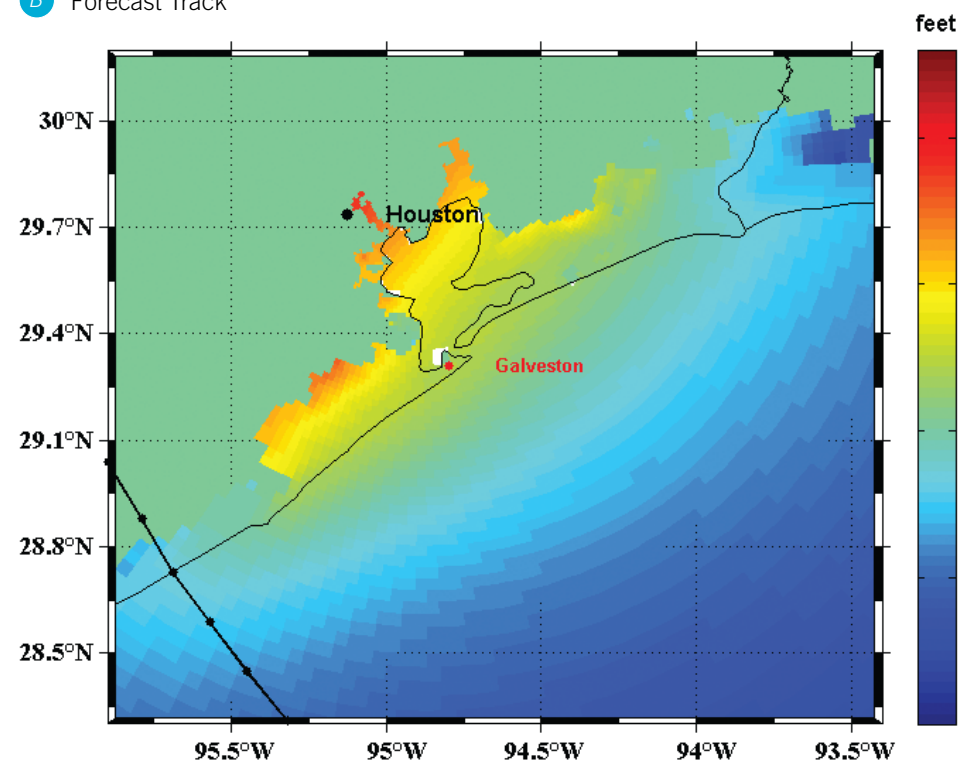
During our real-time assessment of the storm's impact on Texas, the WeatherPredict team used proprietary models to forecast the spatial distribution and height of storm surge flooding along the coast and into Galveston Bay. Figure 10A shows the maximum water level due to Hurricane Ike storm surge simulated using a WeatherPredict proprietary version of the NHC's SLOSH model. The WeatherPredict version of the SLOSH model improves the model's performance for large storms such as Ike, and also for storms that approach the shoreline at an oblique angle. Preliminary observational data suggest a 12-foot storm surge in Galveston, a 14-foot surge at the Texas-Louisiana border, and surge in excess of 15-20 feet in Galveston Bay and northeastward. These numbers are in very good agreement with the computer simulation. It is important to remember

Although the 12-foot surge flooded most of Galveston, causing heavy damage, destruction of potentially much greater severity was avoided due to Galveston's 15.6-foot sea wall (the wall was built 17 feet high, but has since decreased about 2 feet). The surge was still able to flood the city from behind, but the wall prevented a head-on battering by hurricane waves.

Galveston was fortunate that Ike hit the city head-on, rather than just to the west. Ike's highest storm surge occurred about 50 miles to the northeast of Galveston, over a lightly-populated stretch of coast. Figure 10B shows a computer simulation (using the same model) of the storm surge caused by Ike as it was forecasted on September 10 (less than 2 days prior to the landfall). The forecast called for landfall about 50 miles west-south-west of the actual location with maximum winds 15 knots higher than was observed. The figure illustrates that the storm surge in this scenario would have likely overtopped the Galveston sea wall,

leading to much more severe damage. Also, southeastern Houston would have experienced storm surge in excess of 15 feet, significantly increasing the damage to this highly populated area.

Figure 10: A & B - Computer model-simulated storm surge height for actual event (A) and the event as it was forecasted two days prior to landfall (B).

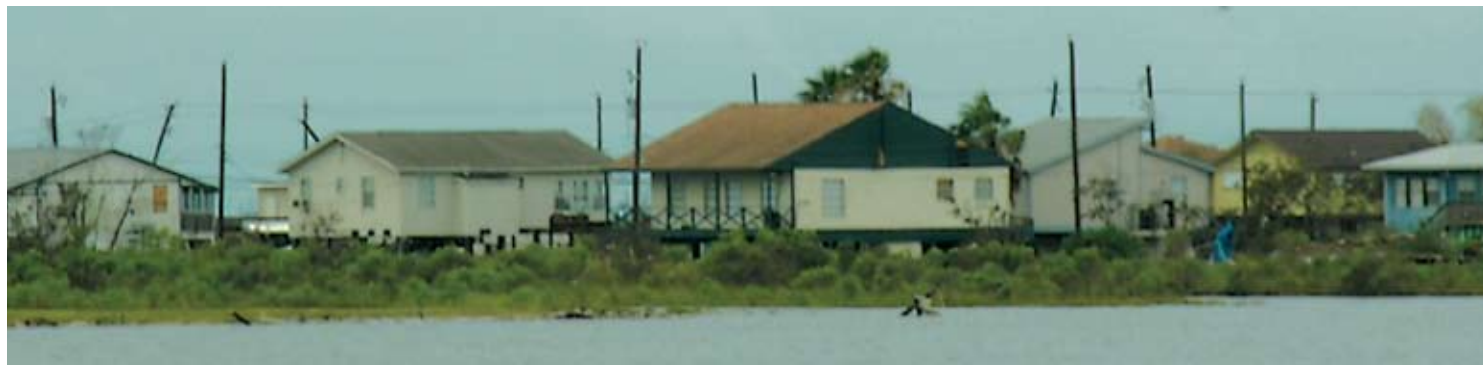
Damage due to storm-related flooding was still quite significant in Galveston, affecting both commercial and residential structures. Interestingly, observation of damage here indicates that actual wind speeds were low in this area, as evidenced repeatedly by the lack of damage to building envelopes (especially roofs) above the storm surge line. Figure 11 through Figure 14 show Galveston exposures that had considerable damage due to storm surge, accompanied by little to no damage attributable to wind.

Figure 11: Galveston on the water – note lack of roof cover damage. The wind damage in Galveston was minimal.

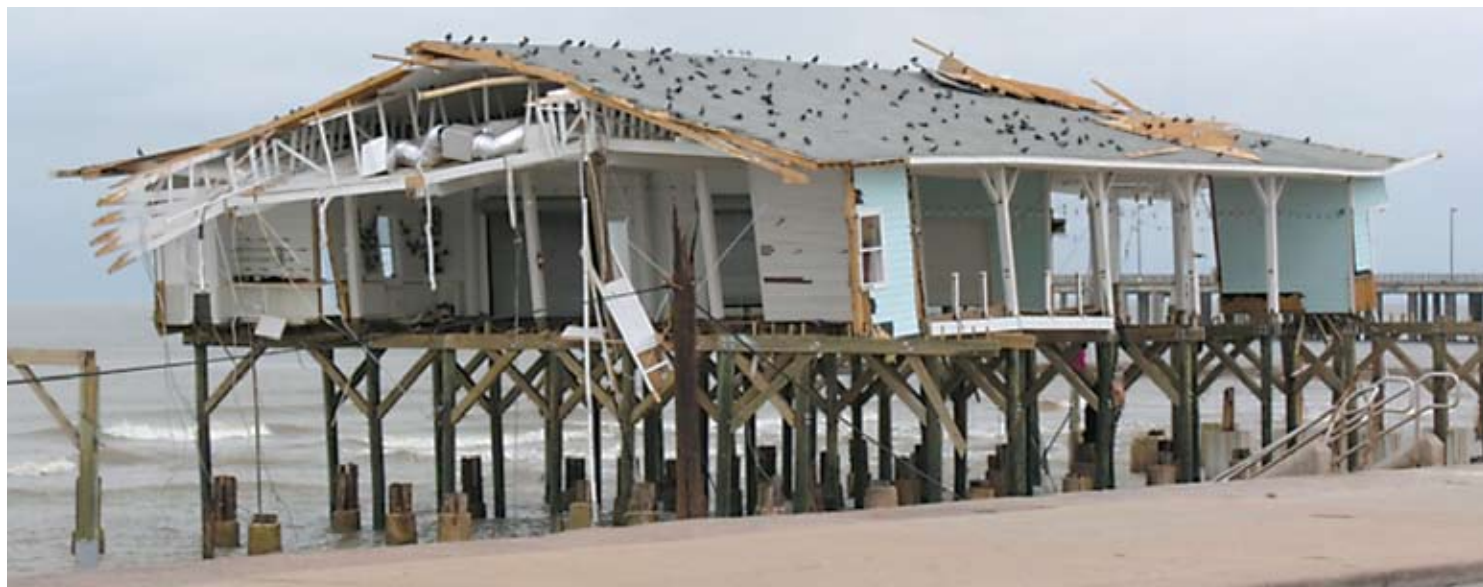
Figure 12: The beach at Galveston Island. Storm surge was significant. Note that the roof cover has minimal damage, indicating winds speeds were lower than expected.

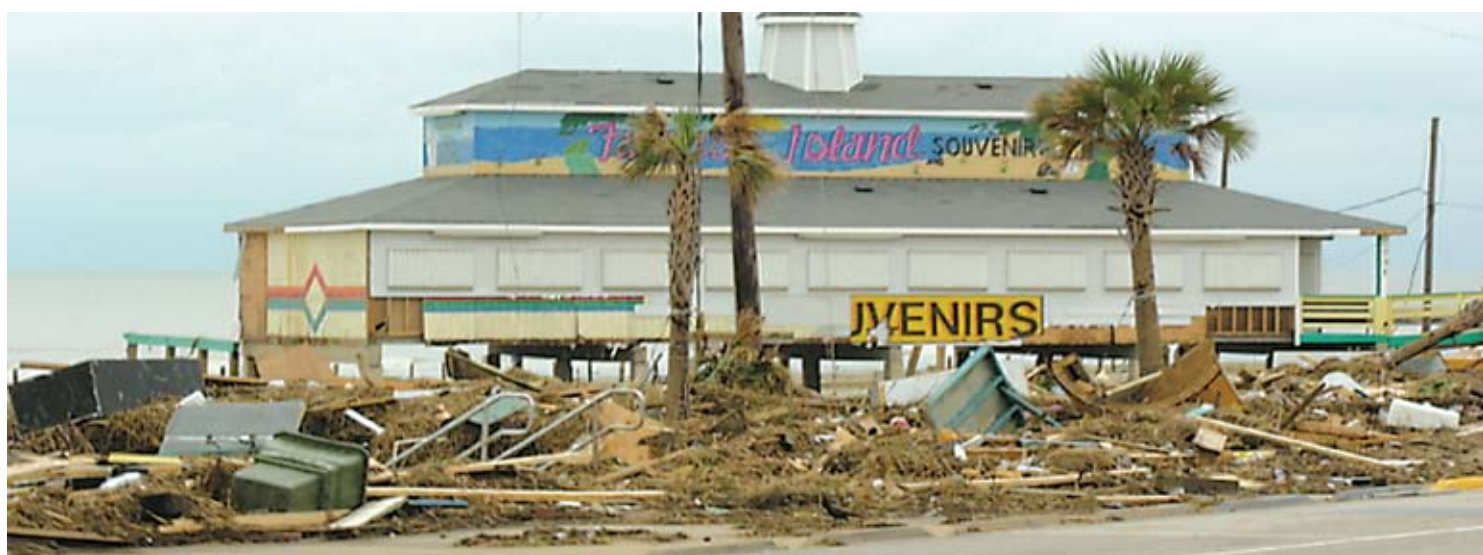
Figure 13: Galveston Island beach-front commercial buildings. Storm surge was significant, as evidenced by the debris line. However, the roof cover has minimal damage, indicating winds speeds were lower than expected.

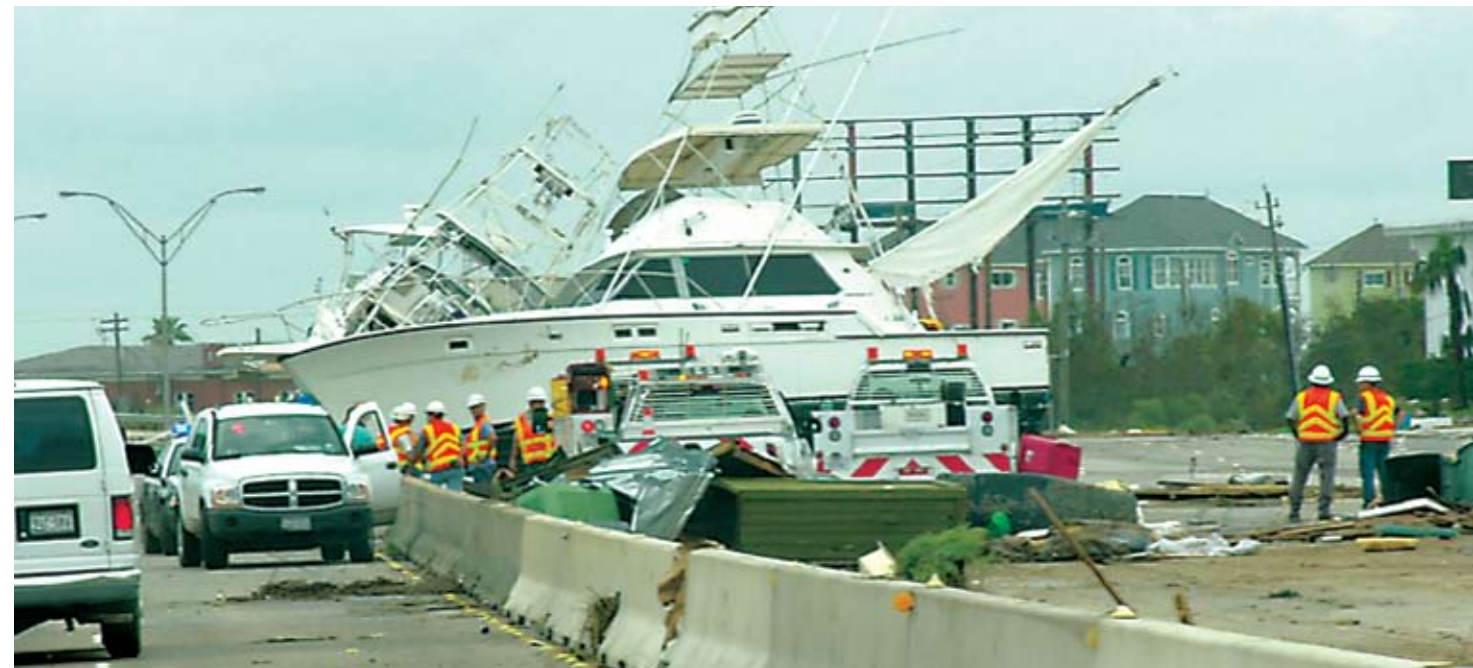
Figure 14: Damage and debris on highway leading to Galveston Island. Photo shows significant storm surge and still water flooding. Note the minimal damage on the roof covers of homes in the background. These roofs are 30 feet high, (i.e., two story house on 10-15 foot piles) and the minimal roof damage again attests to the low wind speeds of Ike.
